Planning for peri-urban development and flooding issues: The story of new urban areas in Can Tho City

Group of researchers

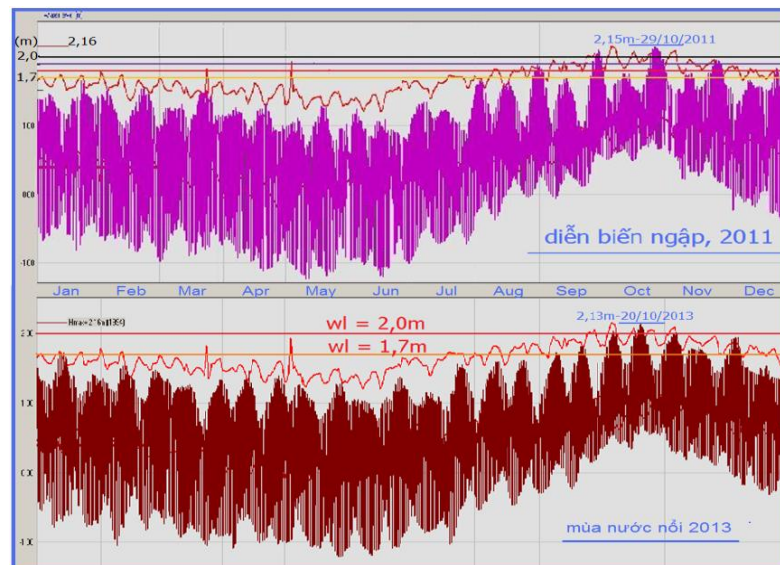
Figure2 Fluctuation in water level in Can Tho City from 2011-2013 (Source: Hydmet)

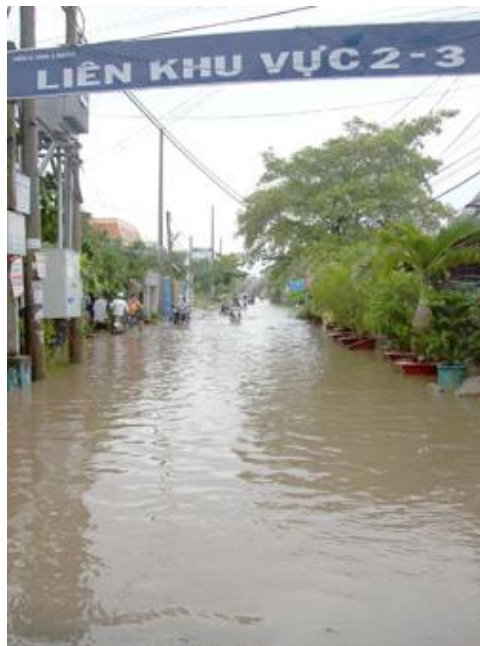
Figure3 Flooding in Alley 4 in neighborhood 2,3, An Khanh District, 2013 (Source: Can Tho City Newspaper October, 2013)

Can Tho City Hydrometeorological center informed: because of the combined effect of water discharge from upstream, tidal flow and Northeast monsoon, daily tidal peak in waterways in Can Tho City continued to rise. Local people described that water rose from 3pm to 5 pm on October 20th. Many urban roads, such as: Hoa Binh boulevard, February 3rd Road, Nguyen Van Linh Road, Tran Van Hoai Road... were deeply flooded.

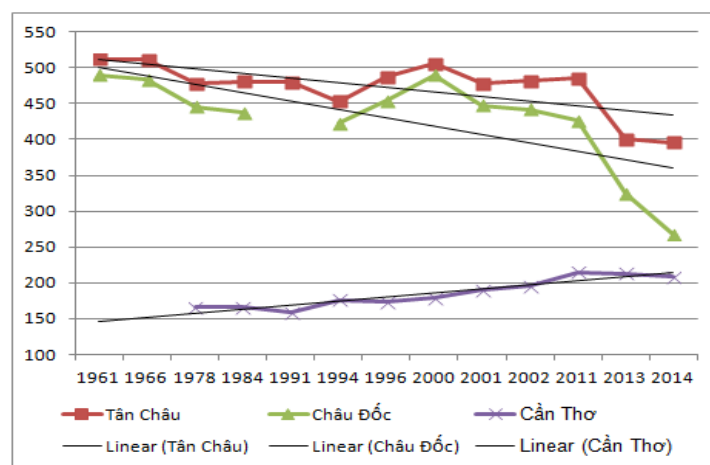
Figure5:Figure 6 Flood peak in Tan Chau, Chau Doc and highest water level in Can Tho City (Source: CCCO accumulated the statistics and data provided by Vietnam Academy for Water Resources and Southern regional Hydrometeorological center)

Tan Chau and Chau Doc are 2 upstream gaging stations located closest to the Vietnam – Cambodia border where Mekong River flows into Vietnam. Based on Figure 6, the highest water level in Can Tho City has tended to increase year after year although the flood peak in Tan Chau and Chau Doc station stayed stable even lower than the previous year. Particularly, in Tan Chau and Chau Doc station, in 2011, 2013 and 2014, the flood peaks were lower than the flood peak in 2000, but the water level in Can Tho City was still higher than the water level in 2000.

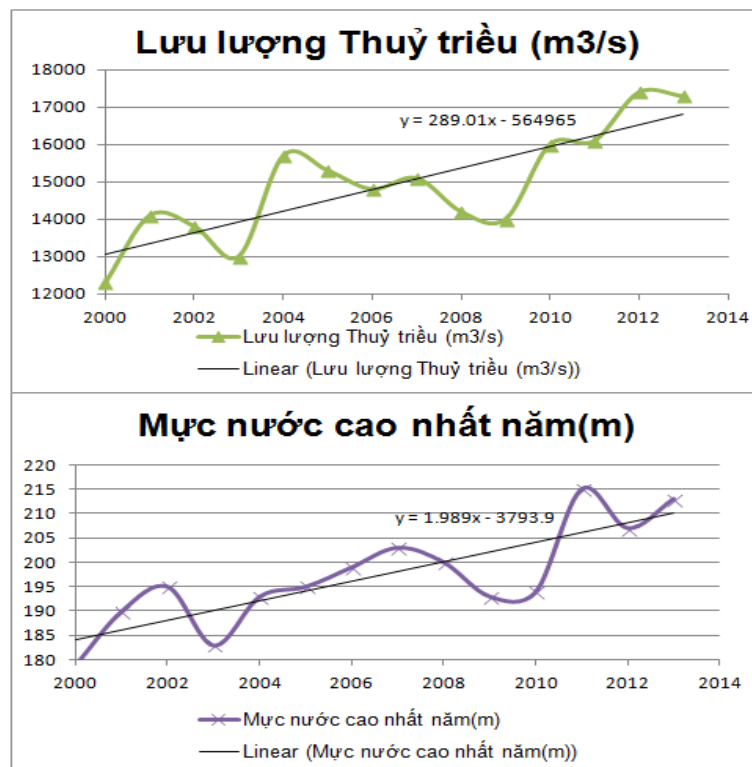
Figure 6 Tidal flow and highest water level in Can Tho City from 2000-2013 (Source: Southern regional Hydrometeorological center)

Tide works as a natural mechanism to supply water to paddy fields, drainage floodwater and reduce flooding in the MKD and Can Tho City. When the tide rises, it becomes a water supply source. And when tide falls, it suction out water toward the sea including inland water and floodwater.

Data of flow in Hau River recorded from 2002 to 2013 was shown in Figure 7 and Table 6. Accordingly, the highest flow in Hau River barely rose. Conversely, tidal flow coming from the sea to inland increased from 12.300m³/s to 17.400 m³/s. Average flow slightly decreased from 6.700m³/s to 6.000m³/s.

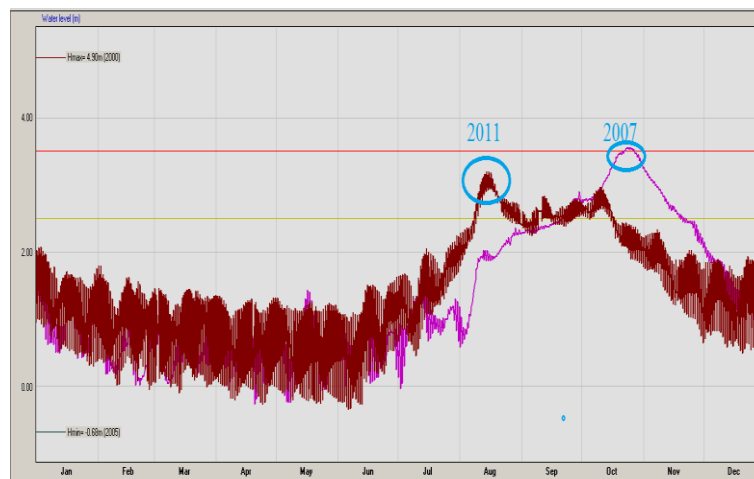
Figure 8 Comparison between tidal oscillation in 2007 and in 2014 in Chau Doc (Source: Hydmet)

Actual measurements showed that the highest water level in Can Tho City has increased approximately 15mm/year including 4mm sea level rise/year. Thus, the research's assumption that land subsidence can be up to 10mm/year is very close to this result. In Chau Doc in recent years, the phenomenon of peak floods affected by tide can be seen as an evident of land subsidence (Figure 11).

Annual land subsidence in combination with tide can be a main reason causing the increase in water level recorded in Can Tho Station year by year.

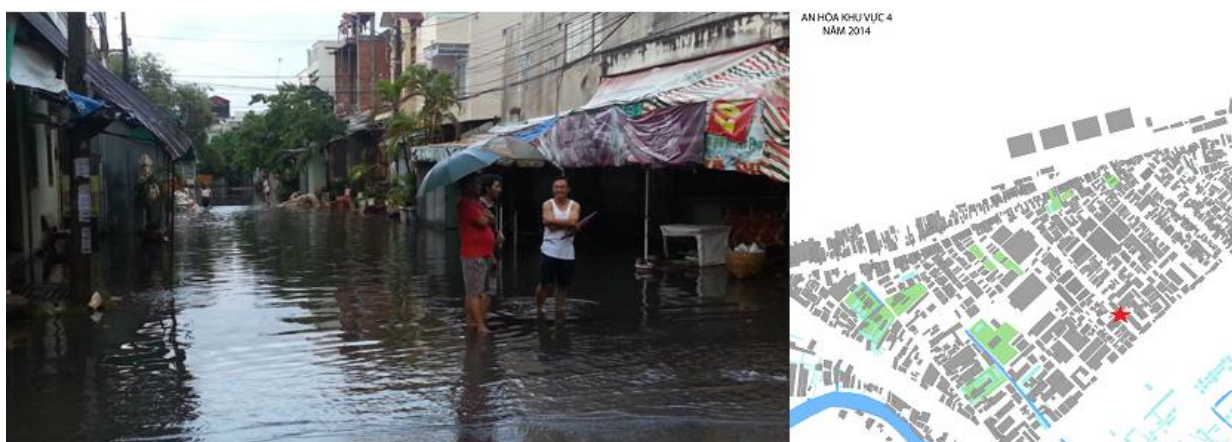
Figure 9 Flooding caused by rain in 256 Alley, 2014

Both rain and tide are water sources causing flooding in Neighborhood 4 in An Hoa Ward. Rain is the major source while tide is just a supplementary source for flooding in this case study.

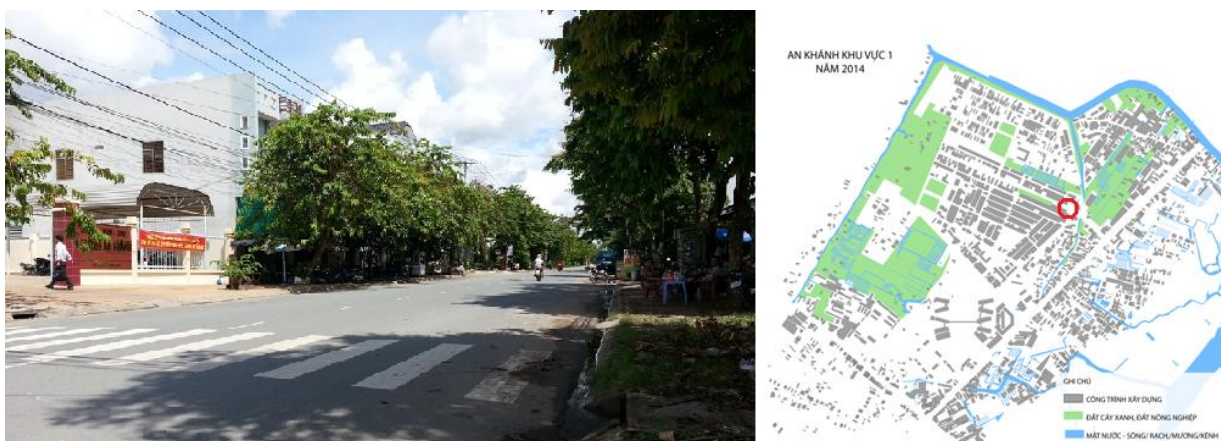
Figure 10 Neighborhood 1, An Khanh Ward, 2014

In 2011, there were orchards and paddy field in his owned land. The natural ground was about 60cm lower than the first floor. Every year, when the “mùa nước nổi” came, he had to embank around his land in order to prevent floodwater from approaching his house and harming the crops. Floodwater used to last for 120 days including 60 days of flooding caused by tide. Tu Ho Canal is a natural waterway transporting floodwater as well as draining floodwater. Notably, at 17:30 on September 17th, 2011, his built embankment was broken and his house and orchards were dumped 60 cm of floodwater. Despite of conforming the city plan, other areas in An Khanh Ward also experienced flooding with at least 10 cm in depth. Until 2013, Thoi Nhat 2 residential area was planned and invested in construction. Ground floor was raised up 200 cm. Mr.Thanh’ first floor was also raised 20cm higher than the ground. This residential area has not been flooded since 2013. Water level in Tu Ho Canal has never exceeded 60cm under new ground level.

Mr. Dang Van Deo who used to live in no. 201 Neighborhood 1, An Khanh Ward, told that before the implementation of city plan, his house was flooded annually. As his land was located in the planned site, he was accepted to resettle to no. 7B Nguyen Tri Phuong Road in Thoi Nhat 1 residential area. Since then, his house has never been flooded. However, not all new residential areas are successful in dealing with flood. He knew that the new resettlement area in the renovation project of Xang Thoi Lake is still flooded because of the inappropriate plan, low-lying ground, small and combined wastewater – rainwater sewer system. The new resettlement area where he is now living was well designed with sufficient sewer system (1m in dimension), high ground, and separated sewer system. In addition, there is a planned residential area behind his house which will be built with emphases on drainage and environmental protection.

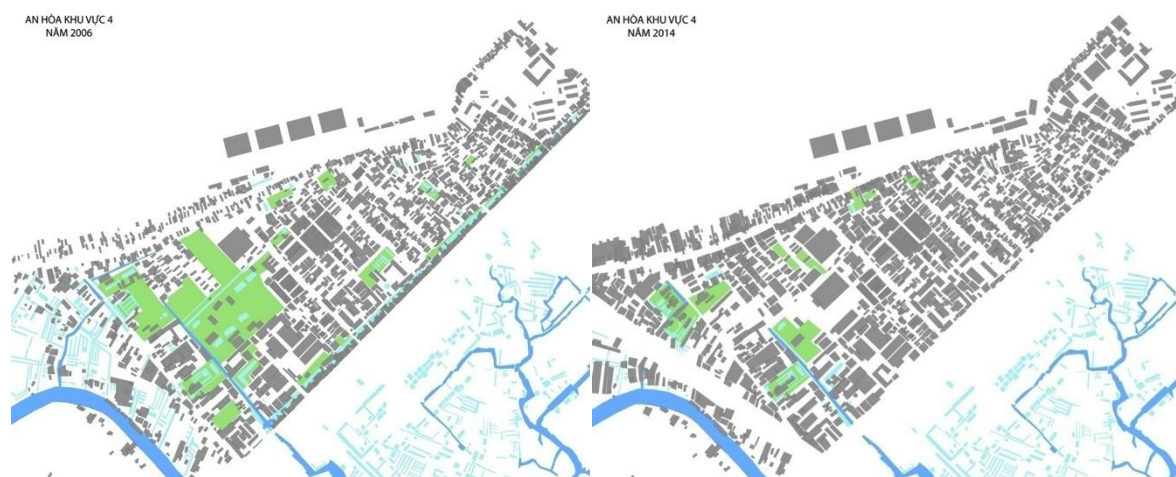
Figure 11 Change in building density in Neighborhood 4, An Hoa Ward in 2006 and 2014

Table 6 Land-use transformation in Neighborhood 4, An Hoa Ward in 2004, 2006 and 2014

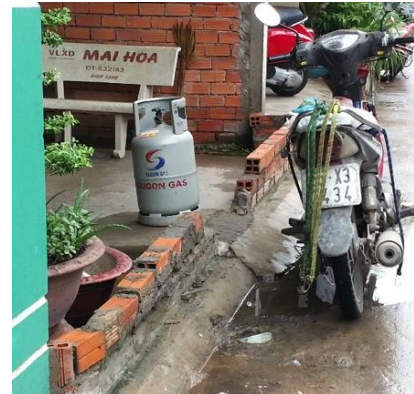
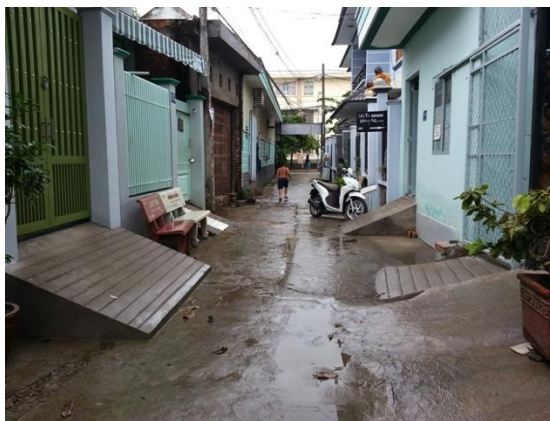
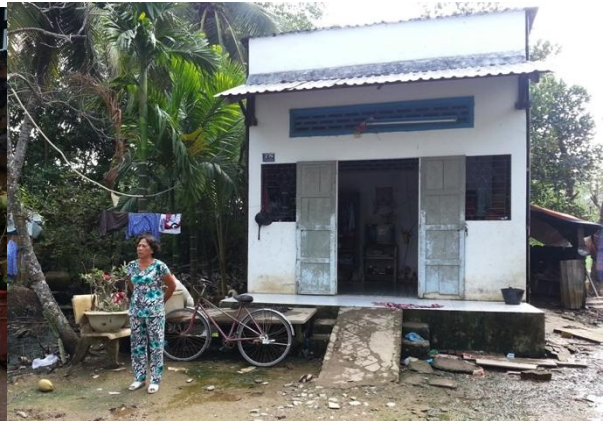
- People with low income or living in rented houses and hostels: they build temporary walls to block floodwater in rainy season and flood season. After that, these walls can be partly removed and used as motorcycle walkways.
- People with medium income: they elevate their first floors or build new house with first floors higher than the regular flooding level.

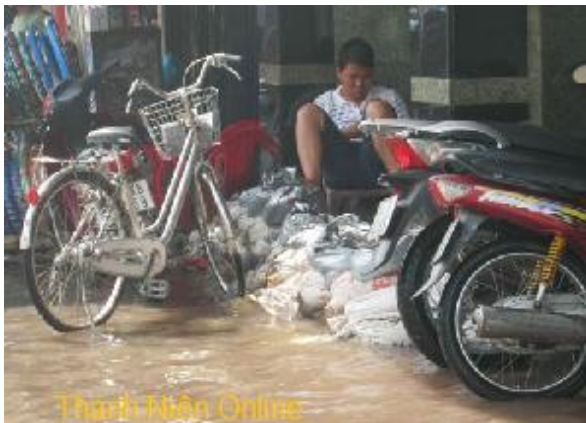
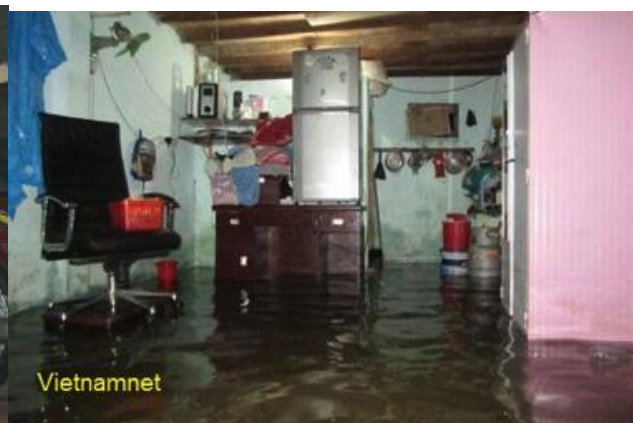
- In case of flooding caused by tide or not able to construct temporary wall, people can use sand bags as temporary barriers surround their houses. This solution is more flexible than heightening first floor and constructing temporary wall.
- In order to prevent incidents during and after the flood events, people lift all their houses' furniture, valuables and perishables up by other wood and brick furniture.
