Post-Bam earthquake: recovery and reconstruction

Mohsen Ghafory-Ashtiany · Mahmood Hosseini

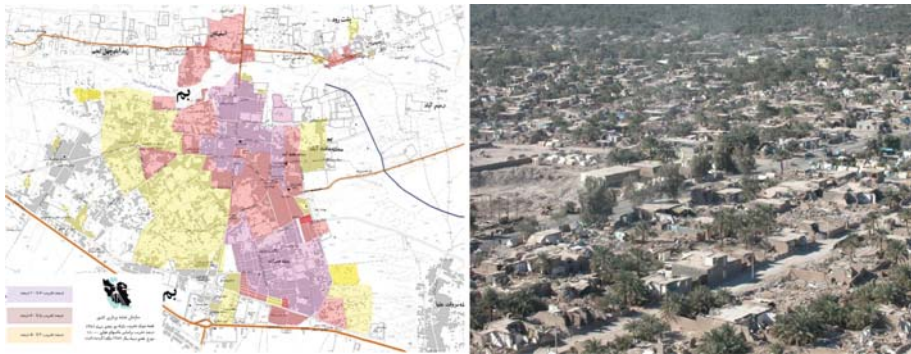
Fig. 1 A general view of Bam and a map of the distribution of damage to buildings

The Bam Ms = 6.5 destructive earthquake at a depth of 10 km leveled the historical city of Bam and Barvat in the early hours of 26 December 2003 at 05:26:26 hours local time. 80% of all buildings were completely destroyed, 17% of all buildings were so badly damaged that they can no longer be used, about 2.8% of the buildings remained undamaged and 0.2% experienced minor damage. The earthquake caused 31,383 deaths and left about 20,000 persons injured and 65,000 homeless. Figure 1 provides a general view of the damage inflicted by the December 2003 earthquake on Bam and its distribution. A total of 27,734 buildings in Bam and 25,022 in the rural area were destroyed and 9,005 were damaged. In addition, most of the public and state buildings, urban facilities, including water, sewage, power, and telecommunication systems, as well as irrigation and agricultural systems, gardens, streets and roads were badly damaged. The Bam historical citadel was totally destroyed.

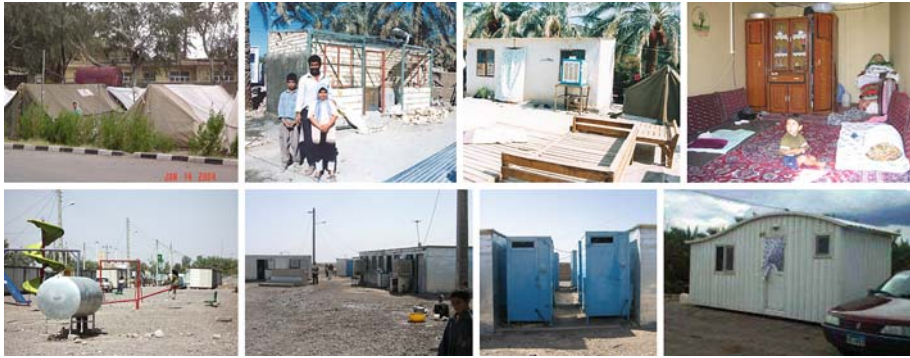
Fig. 3 Example of emergency shelters and prefabricated and in-situ-built temporary housing

The Iran Red Crescent Society began distributing more than 50,000 tents as emergency shelters among those made homeless by the earthquakeas early as the first day of the earthquake. The tents were set up either near the victims’ homes, in groups in an open area or in congregate camps throughout Bam. For intermediate shelter, the Interior Ministry and Kerman Governor Office were ordered to provide the homeless with temporary housing units in the form of prefabricated or in-situ built dwellings, about 16–20 m², equipped with a water heater, air conditioning and sink; sanitary facilities were erected in the area and in the camps housing the survivors. From the 35,905 units, 9,005 units were set up in camp form (which were not welcomed by most of the people and consequently were used for student housing) and 26,900 were built within the owner’s property. About 18,000 showers

and latrines were installed to support the sanitation need of the victims. Most of the survivors were moved from the tents to the temporary housing by the end of March, and the settlements were finished by June 12, 2004, 2 months behind schedule. A better planning and need assessment is recommended for future disaster scenarios. Figure 3 shows various views of emergency and temporary housing units.

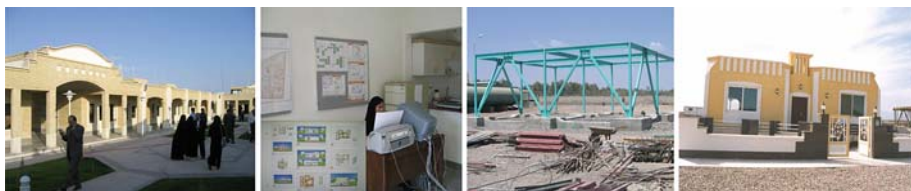
Fig. 4 Construction Bazaar (market) for the reconstruction of Bam, consisting of consulting offices, sample frame and model home from which the people can choose

The role of the construction Bazaar is to provide a supervised aseismic design to new construction based on the ‘‘Iran’s National Building Standards’’ and household demand and to ensure that the reconstruction of the buildings follows the quality-control guidelines. This process enables the Bam resident to choose the pre-approved design and construction models, as shown in Fig. 4. To assure the use of good-quality, controlled construction material, the market also provides the needed materials, which have been approved of by a group of seven material testing laboratories and 17 workshops, at a low and affordable price.

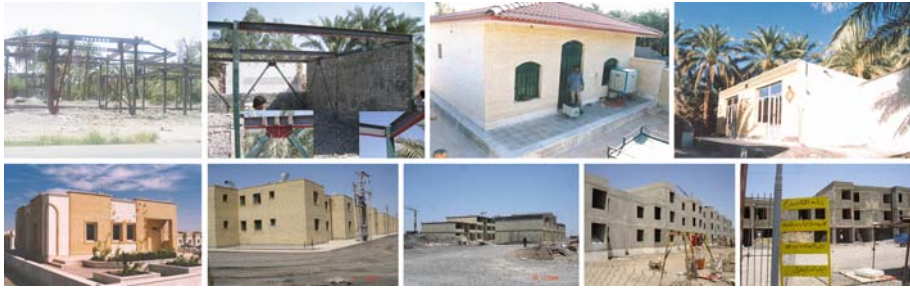
Fig. 5 Reconstruction of Bam in terms of individual dwellings and apartment buildings

The reconstruction plans for residential and commercial units in Bam were implemented in June 2005 and still ongoing. Of the 27,734 units that need to be reconstructed, as of May 2006 a start has been made on the construction of 20,119 buildings, and the (re)construction of 7,206 houses and 72 commercial units has been completed. For those who did not own property, seven housing complexes with 1084 apartment units are being constructed using newer construction techniques; these will be completed by end of 2006. Figure 5 shows the various stages of construction, types of units under construction and completed housing units. The management of this housing reconstruction program takes the form of one resident team with one supervisor for each 100 units, and one head supervisor for each ten teams; the responsible body is the Evaluation and Supervision

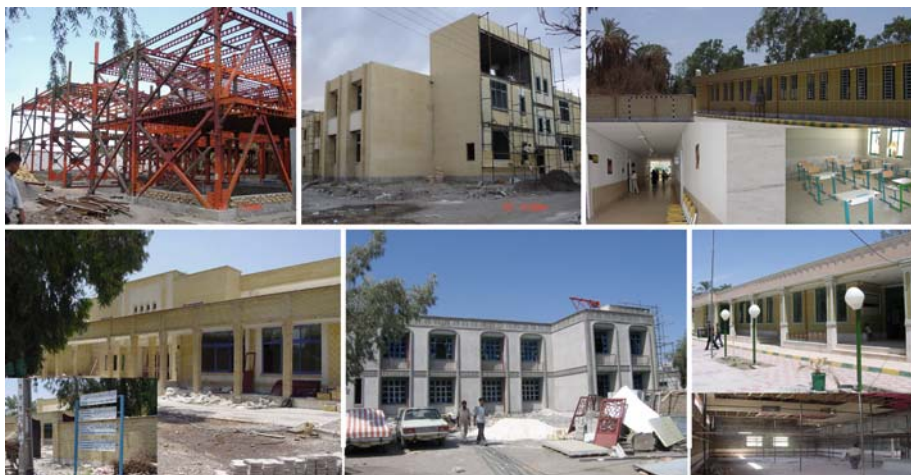
Fig. 6 Reconstruction of various types of schools in Bam, Baravat and the surrounding villages

struction of 131 new schools and repair of 33 schools were given high priority, with construction beginning in the summer of 2004 under the supervision of the ‘‘School Reconstruction Organization’’. Of these 131 schools, 71 were funded by the various governments, 23 by private donations, 28 by funds from foreign countries and ten with the help/cooperation of international organizations. To date, half of the schools have been finished, and the remained will be functional in September 2006. Four educational cultural centers, eight sport halls and six dormitories have been built as well. Figure 6 shows some of the schools that have been built and those under construction. The preliminary assessment indicates that the quality of the school reconstruction has been very good. Relative to the old schools in Bam that were destroyed, the newly constructed schools are safer and better equipped.

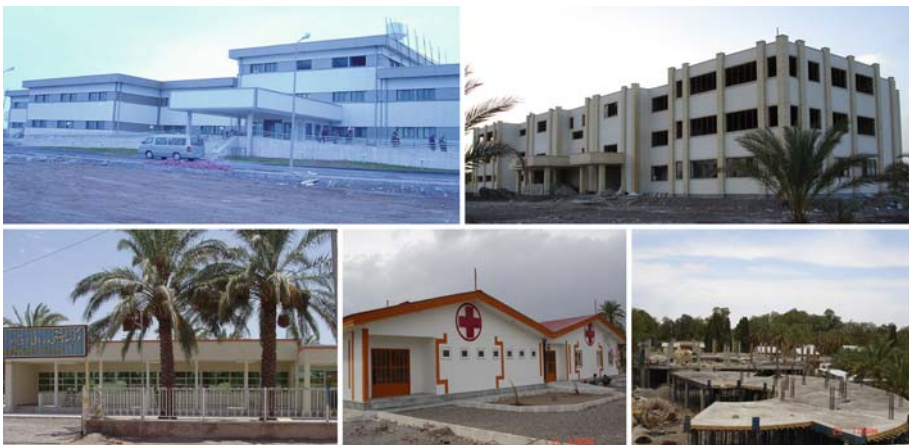
Fig. 7 Reconstruction of hospitals, clinics, health and rehabilitation centers

The two operational hospitals in Bam, with a total of 216 beds, private clinics, health centers, pharmacies and orthopedic centers became un-operational due to the collapse of roofs and walls and damage to equipment. To cover this loss and to be able to respond the post-earthquake increasing demand for medical services, several temporary hospitals were established by the Iranian Red Crescent Society, International Red Cross and non-governmental organizations (NGOs) to provide services with 150 beds. By the spring of 2005 the new Bam hospital with 96 beds became operational, and 18 of the health centers had been repaired. To date, two new General hospitals and 64 new clinics and health centers are under construction, financed with national and international funds. When construction is complete, the residents of Bam and its surrounding will have better and safer medical facilities than they did prior to the earthquake. Figure 7 shows some of the health facilities already constructed and some of those still under construction. Given the increase in the number of orphans (150–5,649) and disabled and needy people (3,750–9,494) as well as the psychological traumas inflicted by the earthquake on people, a large-scale project has been established to provide psycho-social support to residents of the affected area, funded by the Ministry of Health and UNICEF. To date, three rehabilitation centers have been built and five are under construction.

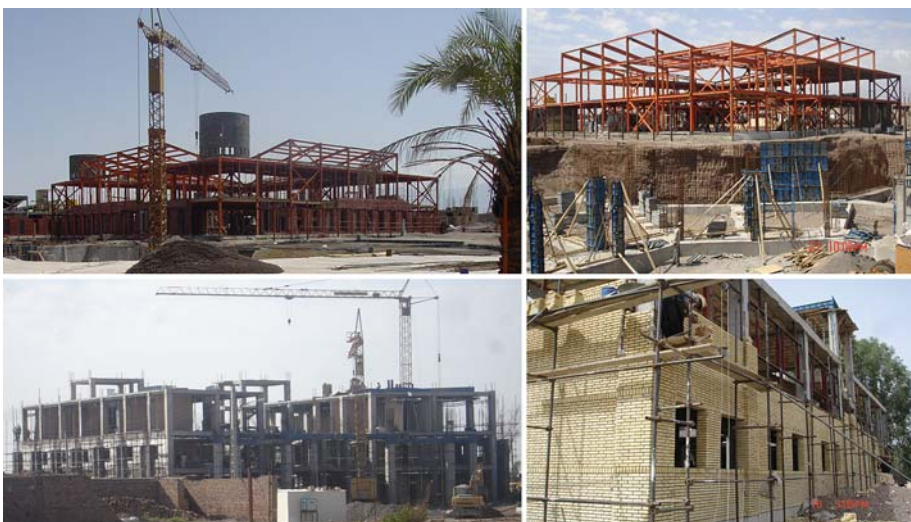
Fig. 9 Reconstruction of Bam government building complexes

In line with the 'new' Bam city being service-oriented, all government and local offices will be housed in several building complexes rather than being spread throughout the city as before. Thirty-one projects, including the (re)construction of police stations, court-houses, post offices, banks and colleges, 170,000 m² in total, are under construction. Progress has been estimated to be 68% (see Fig. 9), and the main government complex will be completed by mid-2007.
